Report 2306

USS TRIPOLI (LPH 10) UNDERWAY VIBRATION TRIALS

ACOUSTICS AND VIBRATION LABORATORY
RESEARCH AND DEVELOPMENT REPORT

October 1966

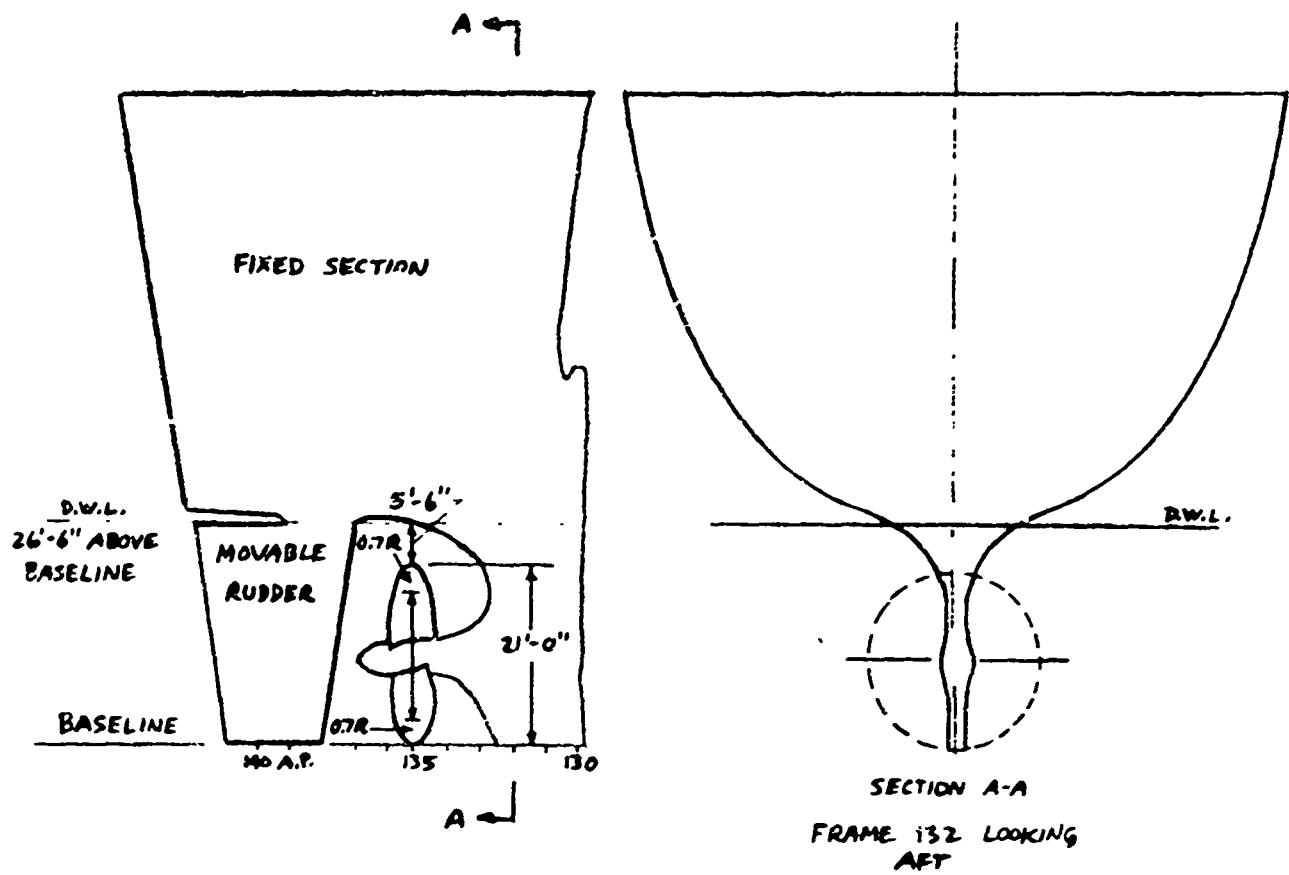
Figure 1 - Propeller and Adjacent Stern Area

Figure 1 shows the propeller and adjacent stern area of the ship.

Prior to the trial the propeller and its rope guard were inspected. No damage was noted of the surfaces and edges of the propeller or of its rope guard.

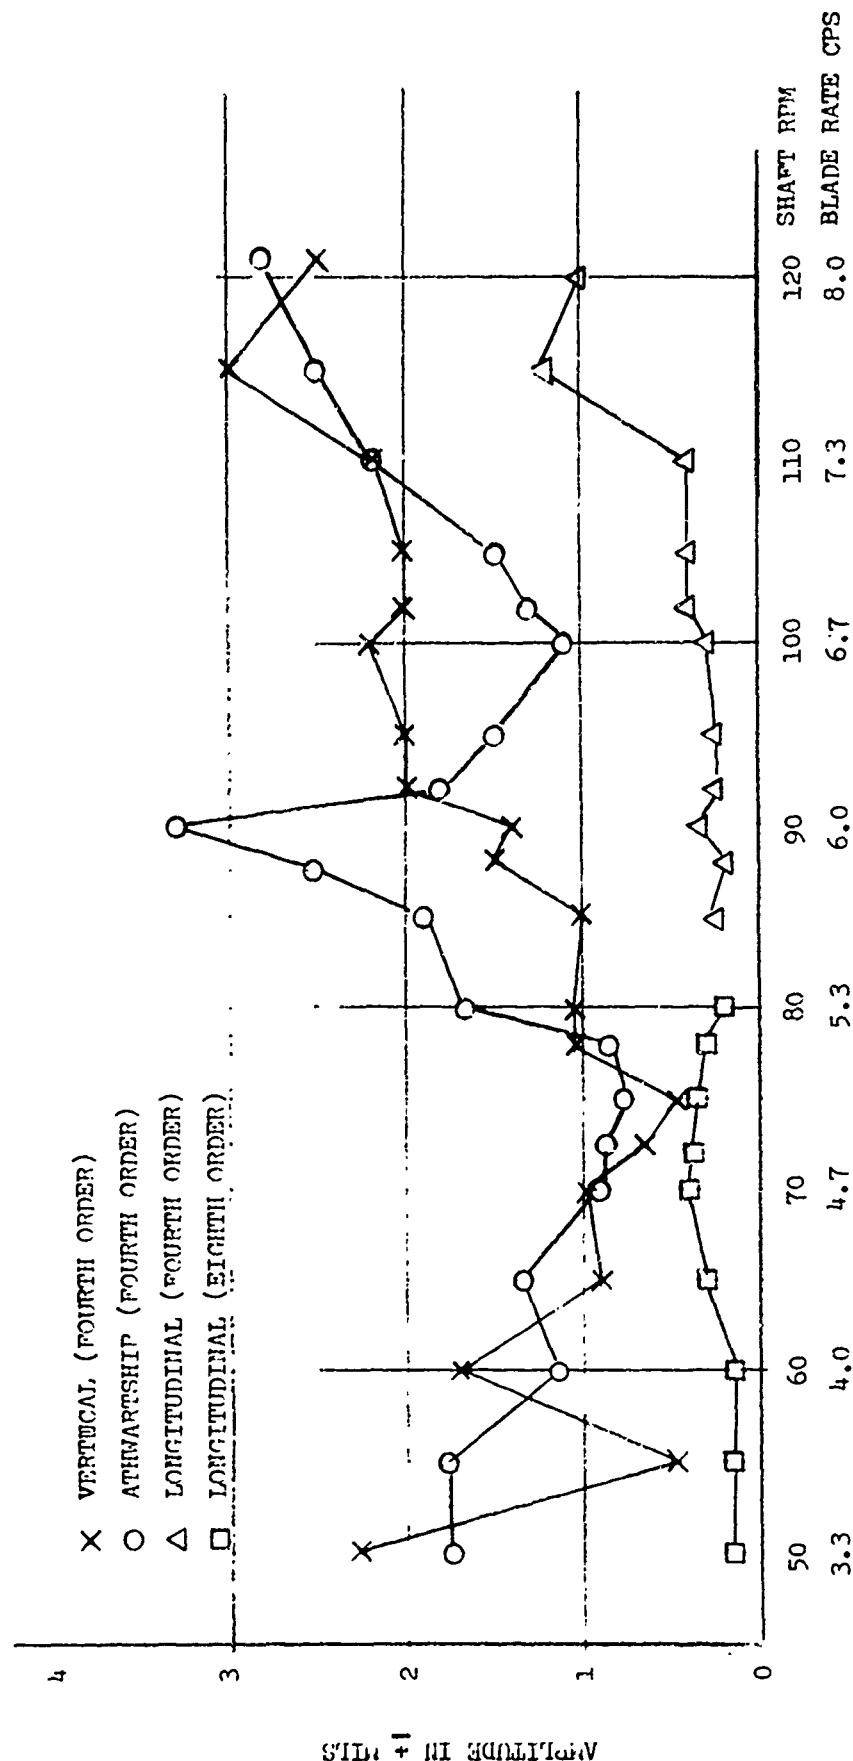
FIGURE 6 - Vertical, Athwartship and Longitudinal Vibration of Hull at Stern, frame 135

The vertical, athwartship, and longitudinal maximum amplitudes measured at the fantail (Main Deck Centerline, Frame 135) versus rpm are shown in Figure 6. The torsional maximum amplitudes measured on the main deck at Frames 135 and 67 at blade frequency are shown in Figure 7. The athwartship maximum amplitudes at Frame 67 measured at blade frequency on the hull main deck and on the mast at the 07 level, (110 ft. level), first platform (140 ft. level), and at the antenna yardarm (168 ft. level) are given in Figure 8. In Figure 9 are presented the maximum athwartship amplitudes measured on the stern-tube bearing and thrust bearing foundation at blade frequency. These results are summarized in Tables 5 and 6. The latter table also includes measurements on the AN/SPS-10 and AN/SPN-6 Radar.

Comparison of the vibrations measured on the fantail, presented in Figures 6 and 7 and in Table 5, with hull vibration calculations for OKINAWA² indicate that (1) the fundamental vertical hull resonance of TRIPOLI was excited by shaft frequency forces at full power (2.0 cps), (2) an athwartship hull resonance which also involves torsional vibration was excited by blade frequency forces at about 90 rpm (6.0 cps), and (3) a vertical hull mode was excited by blade frequency forces at 115 rpm (7.7 cps). Comparison of the "vibrations measured during underway trials on USS TRIPOLI (LPH 10) and USS OKINAWA (LPH 3)¹ in similar sea conditions but with different loading indicates that the hull, mast and island structure, and main propulsion system for these two ships have approximately the same vibration characteristics during free route (straight course) operation; see Tables 1 and 10. Thus the distinction

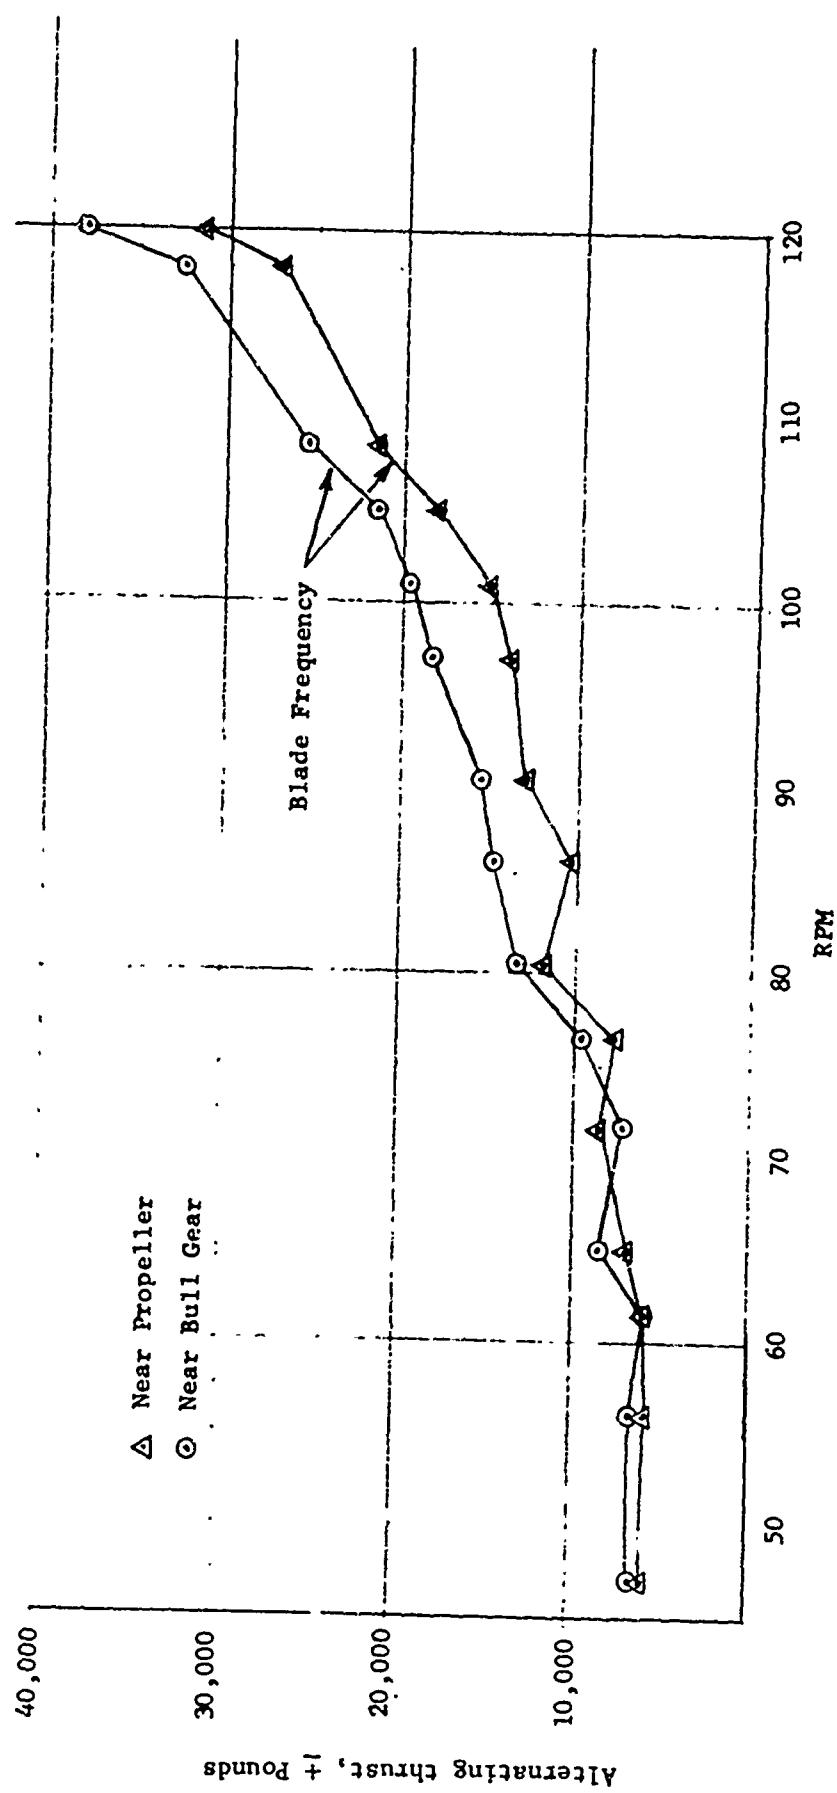
Figure 10- Alternating Thrust in Shaft Near Propeller and Bull Gear, LPH-10.

In Figure 10 is shown the alternating thrust versus rpm in the shaft near the propeller and bull gear. The maximum longitudinal displacements versus rpm of the shaft and thrust bearing housing; of the reduction gear and foundation; of the L.P. turbine, condenser and relative motion between the L.P. turbine rotor and casing; and of the H.P. turbine are shown in Figures 11, 12, 13, and 14, respectively.

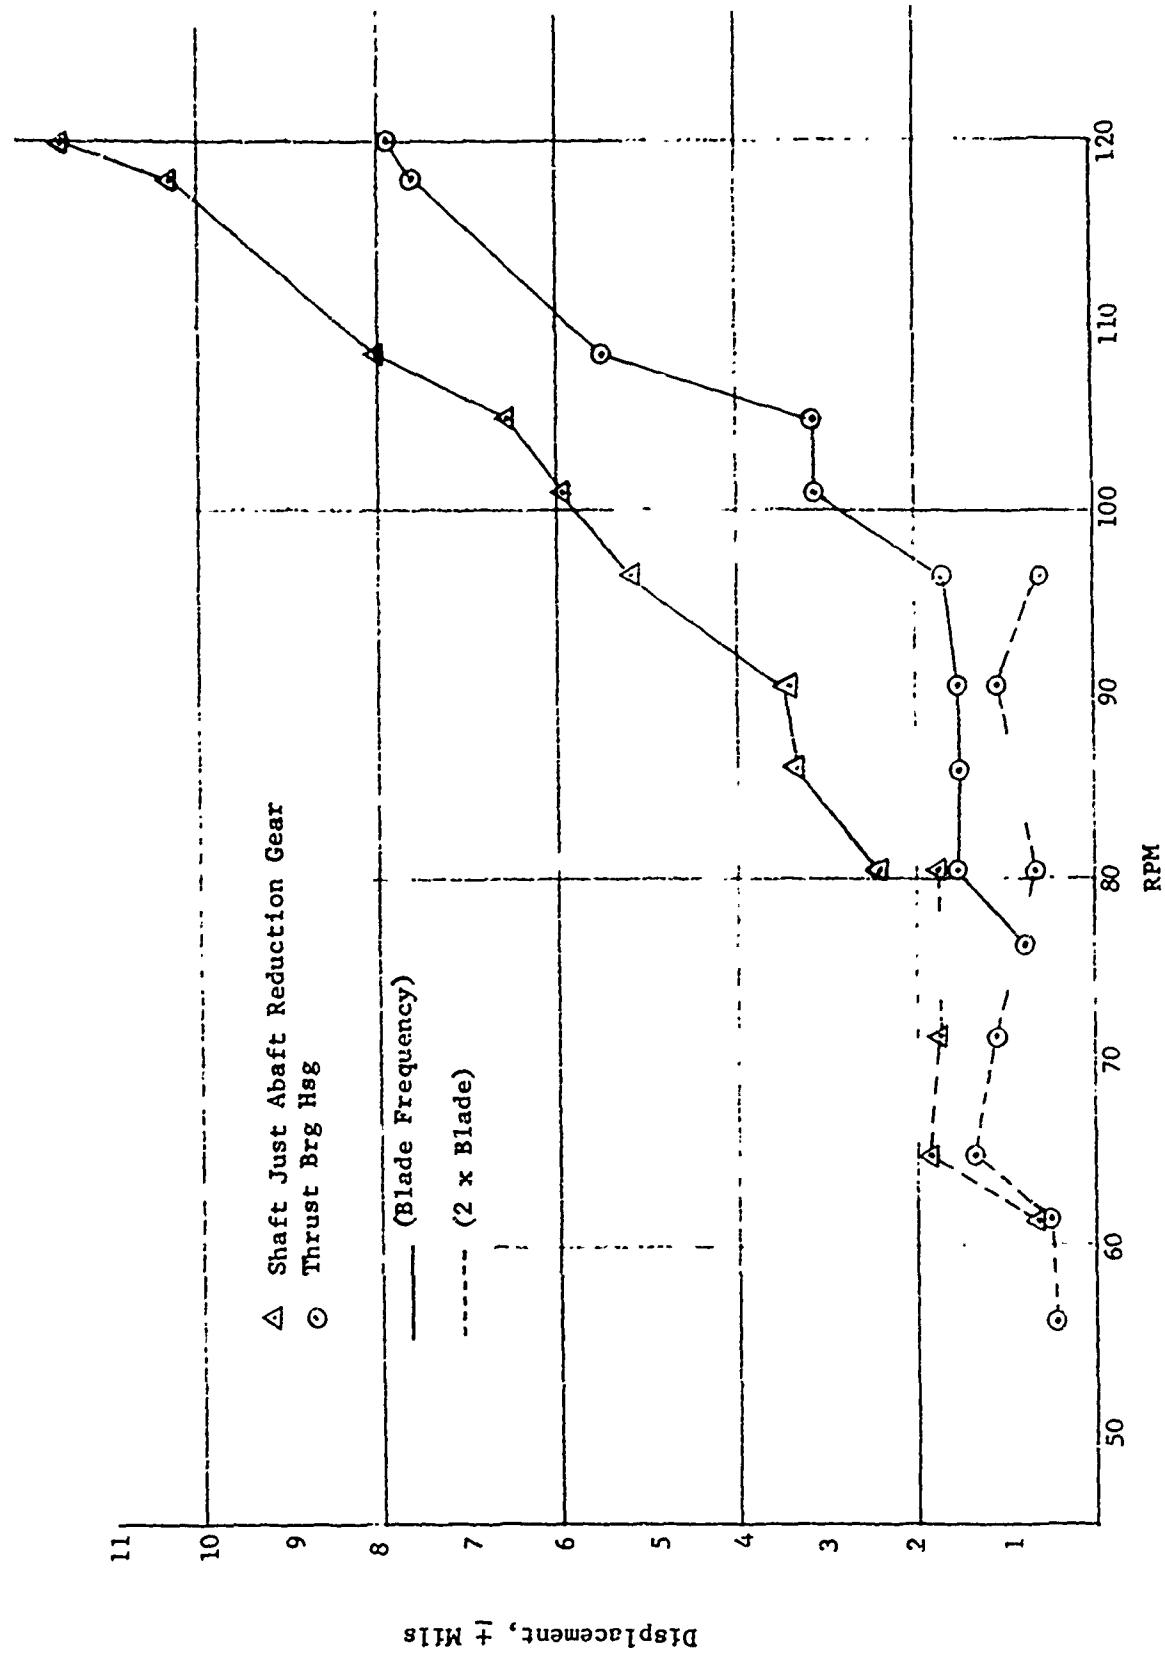
Figure 11- Longitudinal Displacements of Shaft and Thrust Bearing Housing, LFH-10.

The double blade frequency component of longitudinal vibration measured on the shaft and thrust bearing housing peaks at 65 rpm, indicating a longitudinal resonance of the main propulsion system at 8.7 cycles per second. This is the first mode frequency and would correspond with blade frequency at 130 rpm, or 111% of full power rpm. At full power, the amplitudes of the various parts of the machinery in the longitudinal direction are about ± 10 mils. The alternating thrust near the thrust bearing is about $\pm 38,000$ pounds, which is about $\pm 13\%$ of full power thrust. During the starboard turn, the amplitudes are about ± 20 mils, and the alternating thrust is $\pm 64,000$ pounds, or 22.5 percent of full power mean thrust. All the machinery components move in phase and at about the same amplitudes throughout the speed range. No local resonances in the machinery or associated piping were detected. The vibrations measured on the main propulsion system indicate that the longitudinal shafting vibration amplitudes on the LPH 10 and LPH 3 are higher than would be expected on this type of ship, but are not high enough to require immediate corrective action. Also, no additional stiffening is required on the machinery foundation.

8. Although no immediate corrective action is recommended on the LPH 10 main propulsion system, consideration should be given to improvements on the remaining ships of this class. Increasing the number of propeller blades should be investigated even though it would bring the longitudinal critical within the operating range of blade frequency.

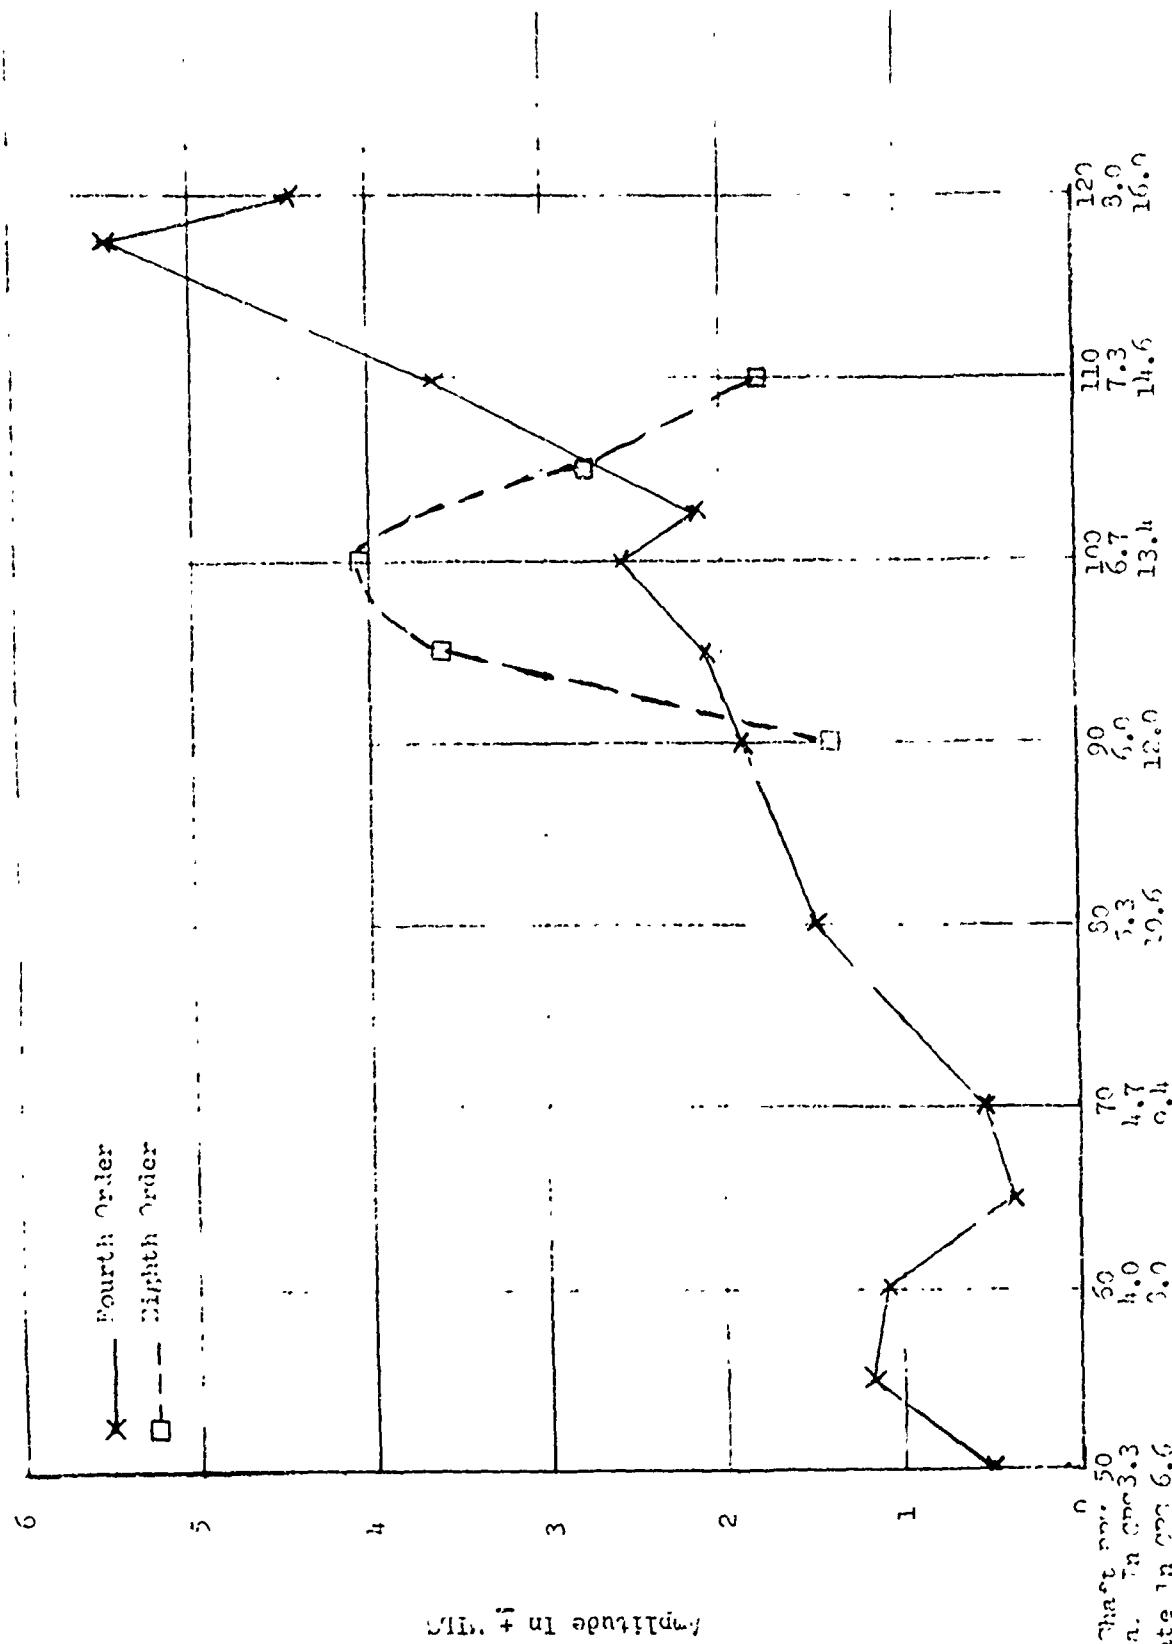
Figure 15 - Vertical response of operating table at frame 120

The vertical response of the operating table at Frame 120 and of the medical area between Frames 115 and 123 to blade and double blade frequency excitation are shown in Figures 15 and 16, respectively. In Figure 17 is presented the athwartship response of the chest X-Ray exposure mount.

4. Permanent stanchions should be installed under the 14-inch transverse beams at the 01 Deck port and starboard sides from Frame 115 aft to the ward areas between the center line and shell. These stanchions should be installed midway between the centerline and shell (i.e., midspan of unsupported beam) or as close to the midspan of the unsupported 14-inch beams as possible. The 01 Deck should be reinforced under the operating tables and the X-Ray unit to mitigate local deck vibration measured near this equipment.

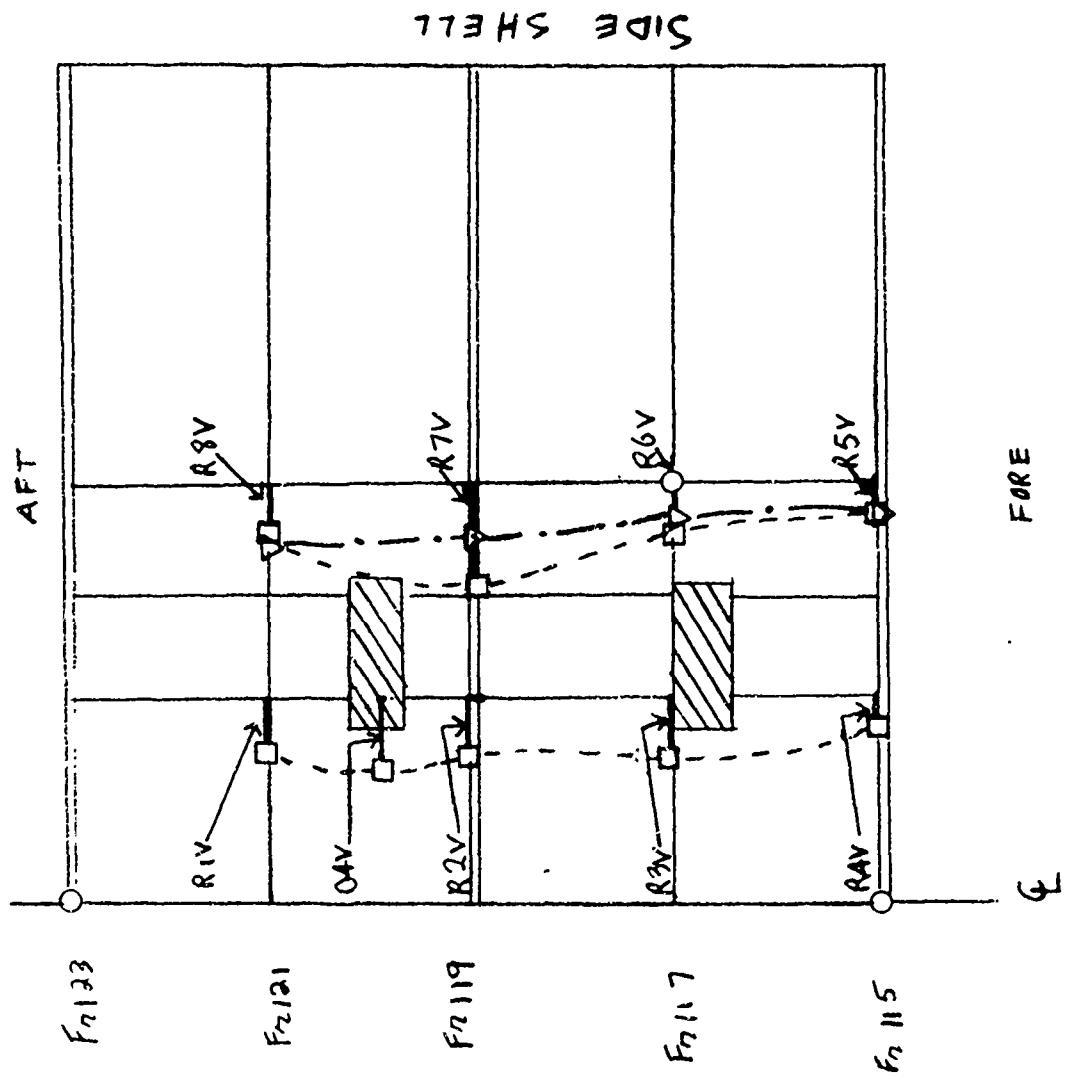
Figure 16 - Vertical Response of Medical Area to Double Blade frequency Excitation
at 100 rad/s (13.3 cps)

Gauge	Amplitude in \pm Mils	01 Level	02 Level
R1V	2.7		
R4V	3.6		
R2V	2.9		
R3V	3.0		
R4V	1.9		
R8V	2.3	3.0	
R7V	5.0	2.4	
R6V	2.3	1.3	
R5V	1.4	1.7

3. The 6-inch longitudinal I beams at the 01 Deck port side between Frames 115 and 123 that intersect athwartship channels should be removed since they contribute little to the stiffness of the deck due to their flanges being cut where they intersect the shallow athwartship channels and piping. The longitudinal beams should be replaced with continuous beams (i.e., beams which are not weakened due to flange cut-outs) and the piping rearranged where necessary to avoid cut-outs.

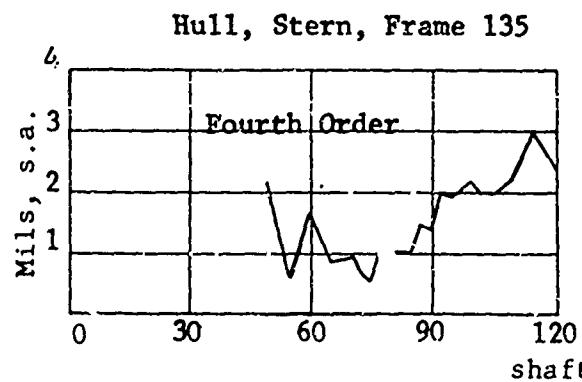
Location of Measurement	Direction	Shaft rpm	Order	Freq. cps	Mils S.A.	Remarks
Hull, Main Deck, Fr 67 Starboard	Athw.	78	Fourth	5.2	1.7	Near second mast athw. mode
Hull, Stern, Frame 135	Vert.	121	First	2.0	12.0	Fundamental hull vertical mode
Hull, Stern, Frame 135	Vert.	115	Fourth	7.7	3.0	Near fifth hull vertical mode
Hull, Stern, Frame 135	Athw.	90	Fourth	6.0	3.3	Near third hull athw. mode
Hull, Stern, Frame 135	Long.	115	Fourth	7.7	1.2	Near fifth hull vertical mode
Gallery Deck, Frame 67	Athw.	105	Fourth	7.0	4.0	
Island 03 Level	Athw.	110	Fourth	7.3	4.7	Fundamental island athwartship mode
Island 07 Level	Vert.	92	Fourth	6.1	3.0	
Island 07 Level	Athw.	110	Fourth	7.3	17.0	Fundamental island athwartship mode
Mast, 00 ft. Above 07 Level	Athw.	78	Fourth	5.2	19.4	Near second mast athwartship
Mast, 30 ft. Above 07 Level	Long.	115	Fourth	7.7	6.0	Near fifth hull vertical mode
Mast, 58 ft. Above 07 Level	Athw.	75	Fourth	5.0	41.5	Second mast athw. mode
